UNITED STATES AIR FORCE
AIRCRAFT ACCIDENT INVESTIGATION
BOARD REPORT

QRF-4C, T/N 69-0384

**82D AERIAL TARGETS SQUADRON
53D WING
TYNDALL AIR FORCE BASE, FLORIDA**

AIRCRAFT ACCIDENT INVESTIGATION QRF-4C T/N 69-0384, TYNDALL AIR FORCE BASE, FLORIDA 17 JULY 2013

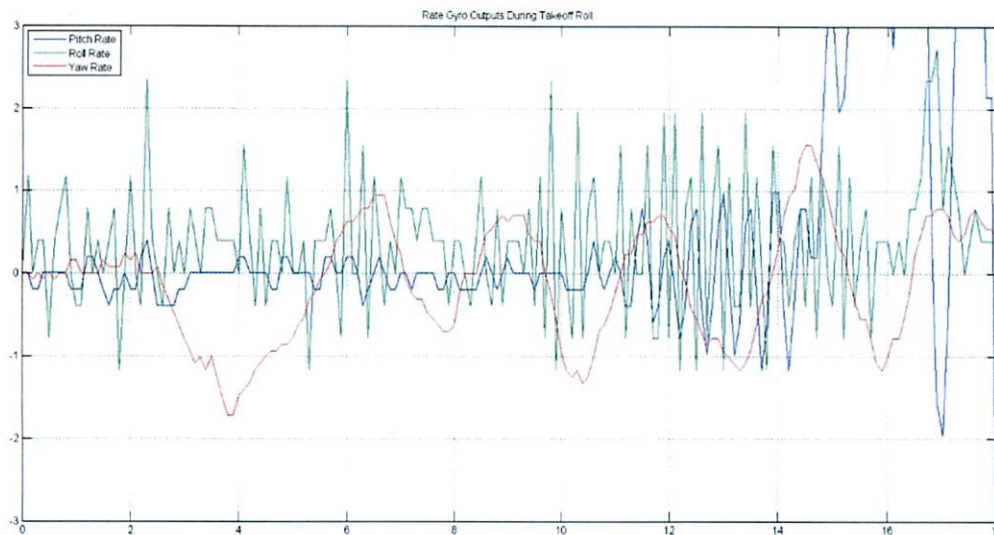
Figure 5: Oscillations of the MA during Takeoff Roll Downloaded by the GRDCS (Tab DD-1.7)

The GRDCS program identified oscillations in the aircraft during the MA's takeoff role as demonstrated in Figure 5 (Tab DD-1.2).

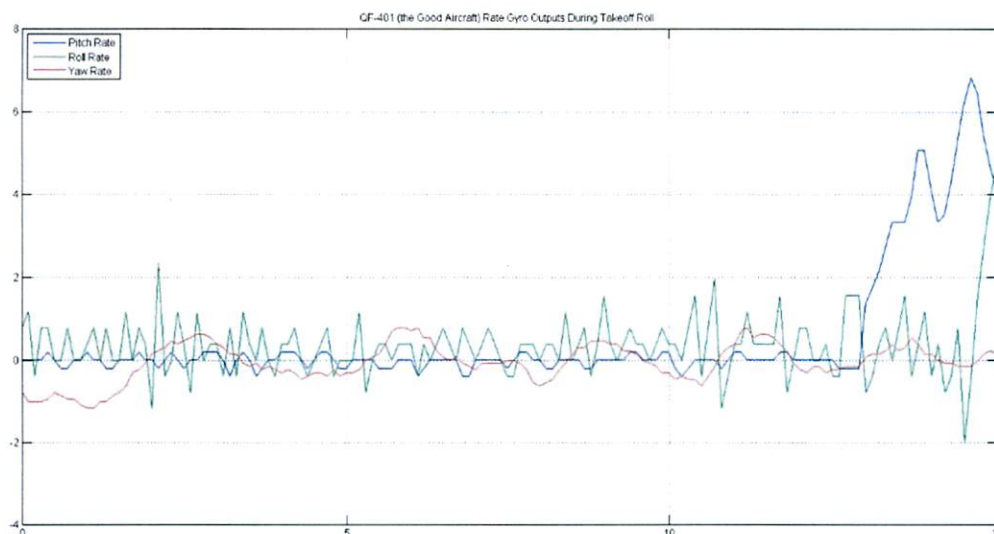
Figure 6: Oscillations of Drone 1 during Takeoff Roll Downloaded by the GRDCS (Tab JJ-1.12)

Additionally, these oscillations were not present during the takeoff roll of the first unmanned aircraft that successfully launched shown in Figure 6 (Tab DD-1.2).

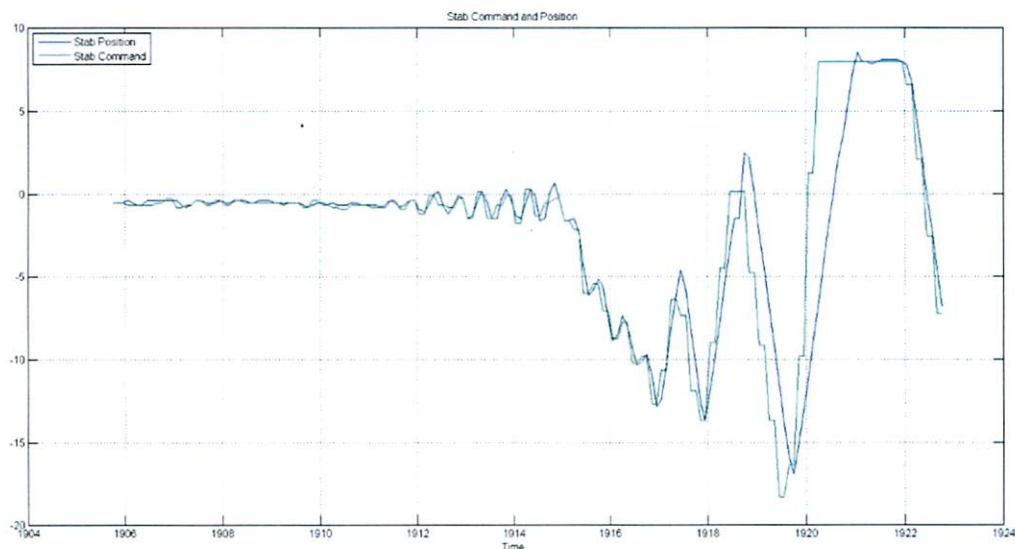
Figure 7: GRDCS Tracking of MA PAFCC Stabilator Electro-Hydraulic (EH) Command and Position (Tab DD-1.10)

As demonstrated in Figure 7, the GRDCS data indicates the PAFCC computed and outputted the Stabilator EH commands correctly based on the inputs to the AHRS (Tab DD-1.5).

Based on this analysis, there is no evidence to indicate that the PAFCC or BAFCC were factors in this mishap.

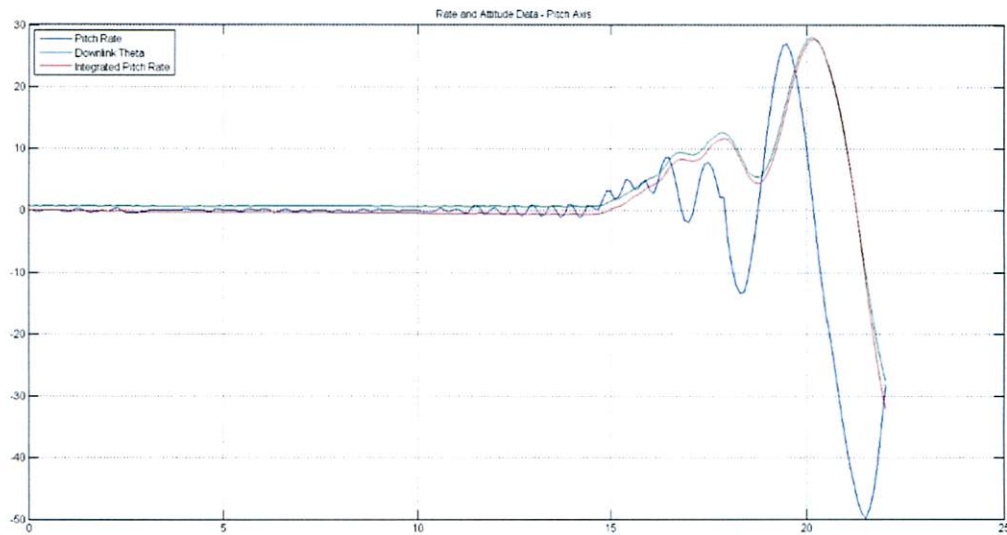
Figure 8: MA Pitch Rate and Attitude Data (Tab JJ-1.8)

The primary and backup AHRS units were destroyed in the mishap and unable to be tested (Tab S-1 through S-10; Tab FF-1.1). However, an analysis of GRDCS data in Figures 8 and 9 demonstrates the proper pitch attitude of the aircraft was sent to the AFCC and downlinked to GRDCS so the software internal to the AHRS was operational during the mishap. (Tab DD-1.5).

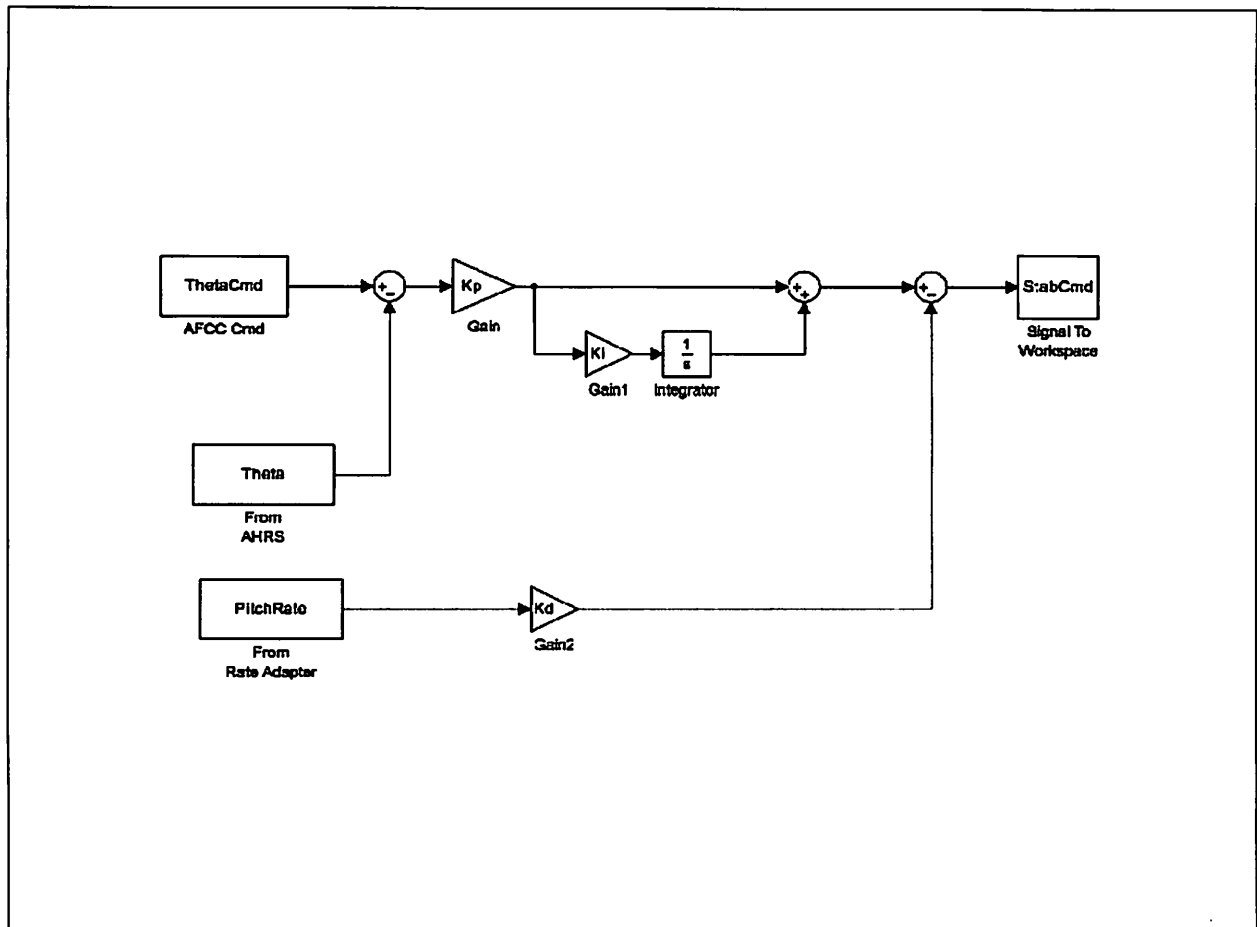
Figure 10: Stabilator Command Basic Structure (Tab JJ-3.1)

The stabilator command is comprised of two feedbacks and a command (Tab DD-3.1). The basic structure is shown in Figure 10. The AFCC commands came from the summation of controller uplink commands and AFCC auto sequence commands (Tab DD-3.1). In this particular case, the uplink command was 0.0 and the ATO auto sequence command was 12 degrees (Tab DD-3.1).

The Theta feedback is the pitch attitude feedback from the AHRS, and the Pitch Rate feedback is the AHRS pitch rate fed thru the rate adapter and then into the AFCC (Tab DD-3.2). The pitch attitude (Theta) was, in this case, simply the integral of the rate (Tab DD-3.2). The pitch attitude and the integral of the pitch attitude agree, which confirms that the software in the AHRS unit was operating correctly (Tab DD-3.2). The true pitch attitude is unknown; however, the video of the mishap demonstrates what the pitch attitude “should” be (Tab DD-3.2). In this case, the downlink data shows the MA lifted correctly to the 12 degree mark, then suddenly pitched down, then violently pitched up past the 12 degree mark, then pitched down just prior to impact, similar to the actions of the MA in the accident video recording (Tab DD-3.2). Therefore, the evaluated pitch attitude collected from the GRDCS coincides with the video feedback of the mishap (Tab DD-3.2).

In the takeoff mode of the QRF-4C, the basic loop structure of the pitch attitude control loop has a bandwidth of about 1.0 Hertz (Tab DD-3.2). Therefore, in normal operating conditions the sensors in this aircraft system have very high bandwidth compared to the control loop they are used in (Tab DD-3.2). The AHRS bandwidth should be in the 10 Hz or better range if operating correctly (Tab DD-3.2). If a sensor "loses" some of its bandwidth, the loop is destabilized (Tab DD-3.2). Since the AHRS did not fail completely, the AFCC did not subsequently fail (Tab DD-3.2). Therefore, the fact that the aircraft went unstable indicates that somewhere in the AHRS system, bandwidth was lost causing the loop to become unstable (Tab DD-3.2).
